High-Frequency Testing of Composite Fan Vanes With Erosion-Resistant Coating Conducted

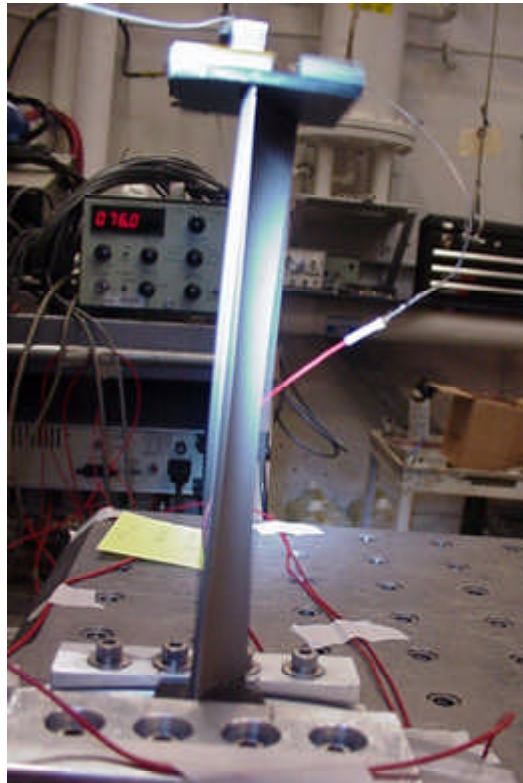
Coated vane undergoing vibratory testing with displacement amplitudes visible in photograph shadowing. Total vane height is approximately 15 cm (6 in.).

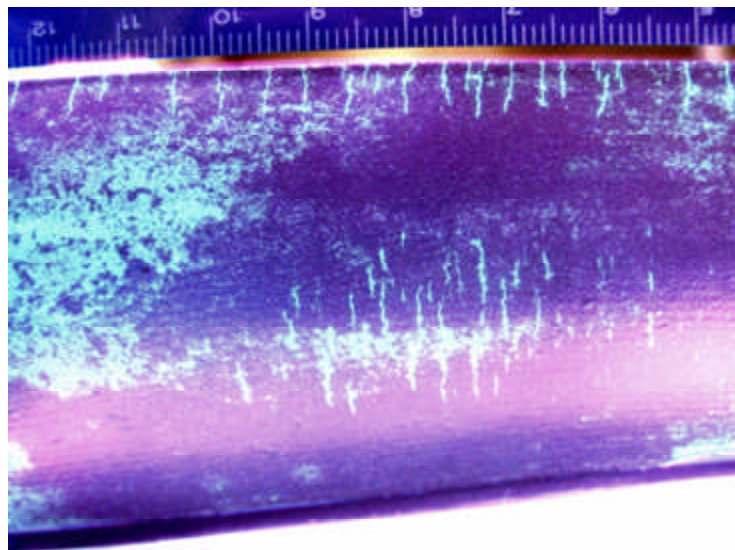
Trailing edge and convex midsection cracks visible with fluorescent dye after 10 million cycles at a strain amplitude of 1300 to 1400 me. The scale marker is in centimeters. Maximum crack length is about 0.7 cm on the edge and 1.8 cm in the midsection.

Accumulation of 10 million cycles at a strain amplitude of two to three times that expected in the engine (approximately 670 Hz and 20g) led to the development of multiple cracks in the coating that were only detectable using fluorescent-dye penetrant inspection. Cracks were prevalent on the trailing edge and on the convex side of the midsection. No cracking or spalling was evident using standard optical inspection at up to $\times 60$ magnification. Further inspection may reveal whether these fine cracks penetrated the coating or were strictly on the surface.
